# Architects and Engineers Investigating Destruction of WTC Skyscrapers on September 11

Technical Analysis

NIST's final report on the collapse of World Trade Center Building 7, issued in November 2008, has many flaws, including blatant fraud.

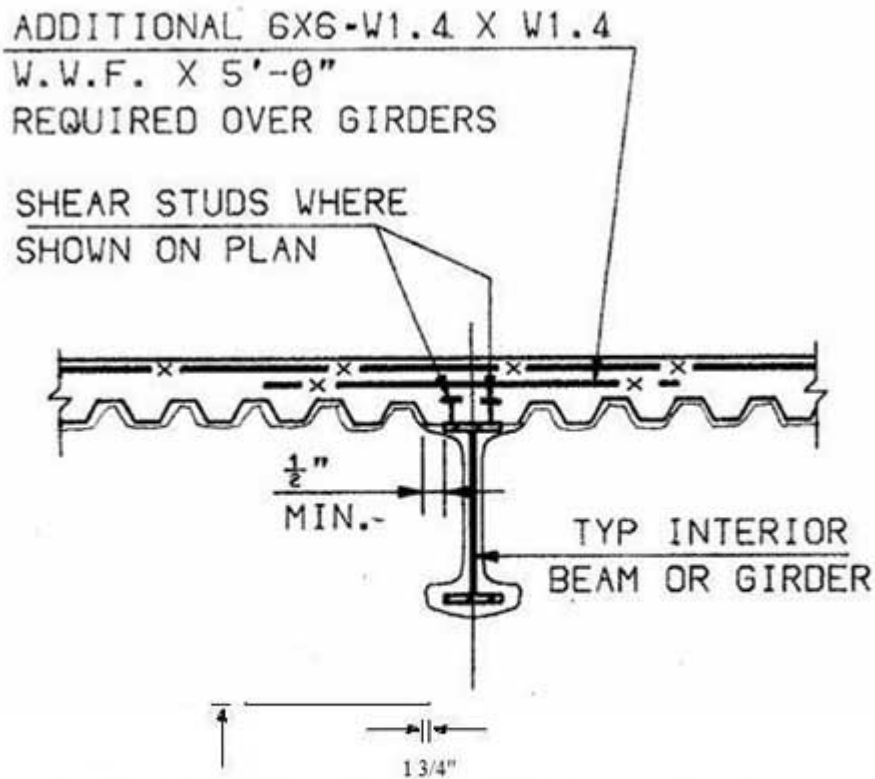
Based on fabrication shop drawings (Cantor 1985)  
**Figure 12-4. Typical composite floor construction detail (along weak direction).**

\*NCSTAR 1-9, Vol. 2, Figure 12-4 (below)

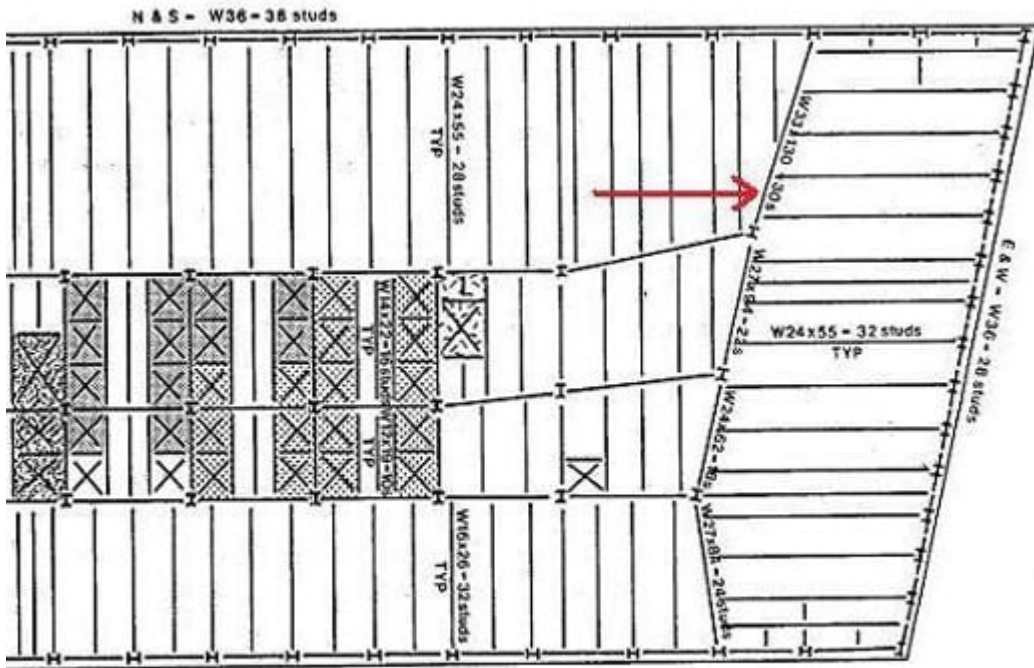
[Seven World Trade Center, New York, Fabrication and Construction Aspects](#)

Structural engineer Ron Brookman found that the Salvarinas "Fabrication and Construction Aspects," a document that outlines the basic structural system of WTC 7, shows 30 shear studs on the girder in question (see page 20 of the Seven World Trade Center link above the next graphic).

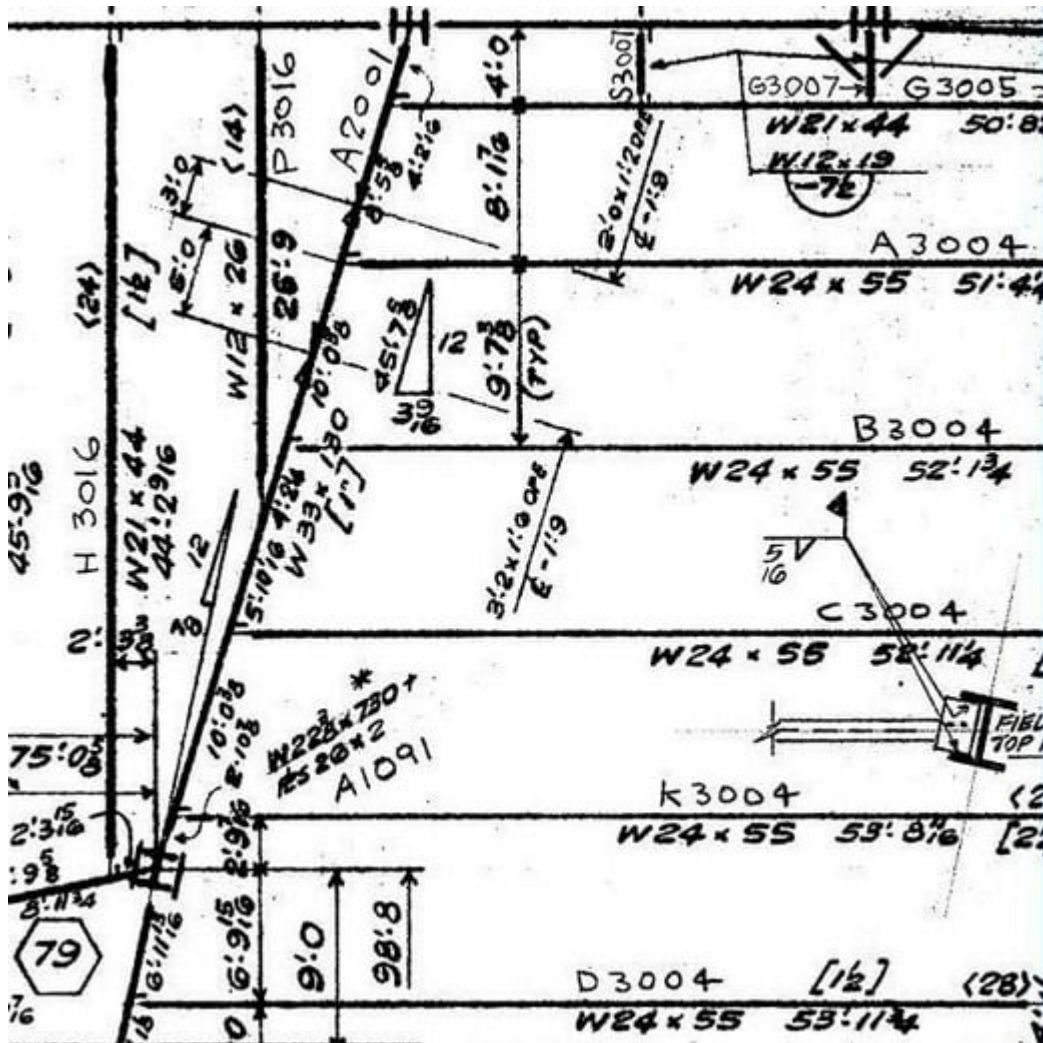
Drawing S-8

The erection drawings in the NIST final report show field-installed studs on the beams but not the girder between columns 44 and 79. A note on the drawing says, "For additional studs see cust. dwg. S8," but the corresponding note has been erased.

Has Revision I been redacted/scrubbed here?

NIST used a drawing without the shear stud notation in the final report on WTC 7. The space with the missing shear stud notation was instead used for the angle notation.

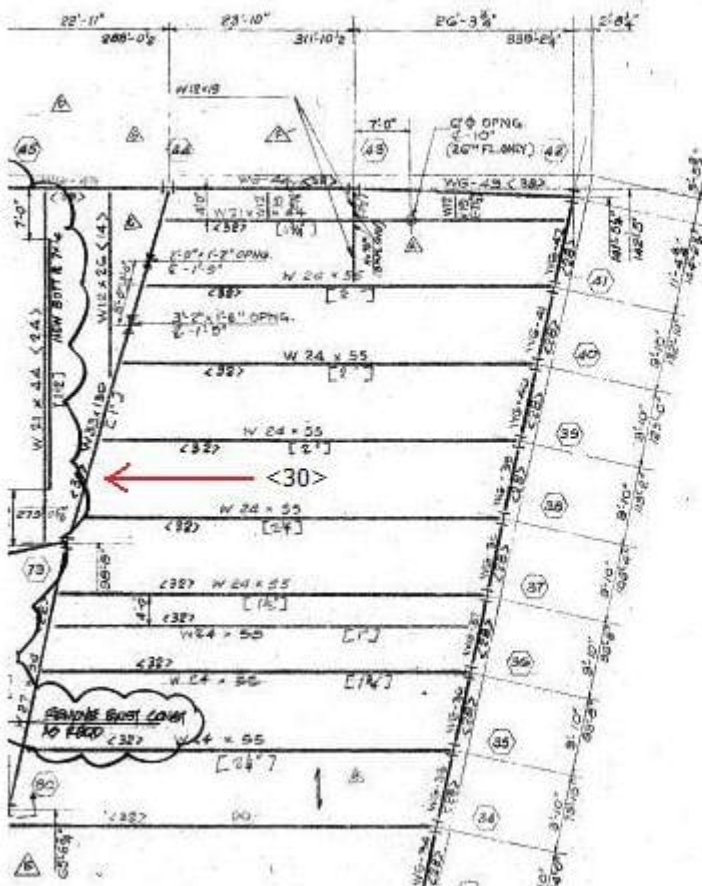
DWG.  
 S-8-10

A FOIA release in 2012 contained drawings that show <30> shear studs on that girder on Floor 10 and Floor 20. It is simply not consistent or logical to have shear studs on the girder on some floors but not on other floors. See drawings S-8-10 and S-8-20 below.
