# Radiation Levels in the Fukushima Reactor Are Soaring Unexpectedly

*Radiation is at its highest since the 2011 meltdown.*

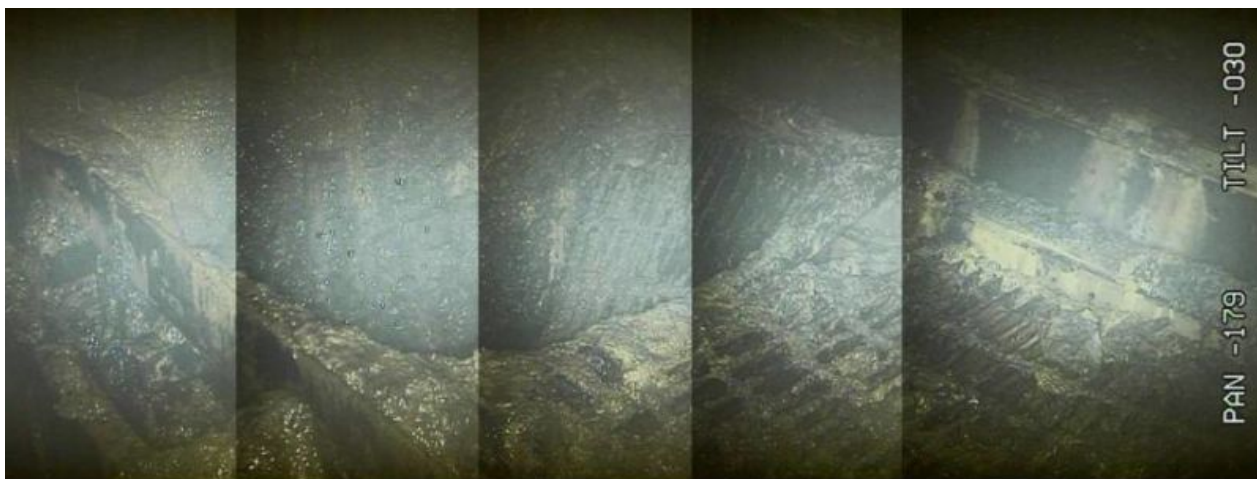
Adding to that hypothesis is the fact that the images reveal a gaping [1-metre \(3.2-foot\) hole](#) in the metal grate underneath the pressure vessel - which could indicate that nuclear fuel had melted out of it.

On Monday, Tepco also saw [“black chunks”](#) deposited on the grating directly under the pressure vessel - which could be evidence of melted fuel rods.

To get an idea of the radiation levels inside, the team used a remote-operated camera to take photos of the area – the deepest point in the reactor to date – and then analysed the electronic noise in the images to measure radiation levels.

The fact that these readings were so high in this particular location suggests that maybe melted reactor fuel escaped the pressure vessel, and is located somewhere nearby.

Naturally, Tepco is reluctant to jump to any conclusions on what the black mass in the images could be until they have more information.

“It may have been caused by nuclear fuel that would have melted and made a hole in the vessel, but it is only a hypothesis at this stage,” [a Tepco spokesperson told AFP](#).
