# Debunking the Real 9/11 Myths: Plane Impacts, Fire Damage and Melted Steel

Part 2:

By [Adam Taylor](#)

2012 Article published by Architects and Engineers for 911 Truth, republished by AEA911Truth and Global Research in October 2018

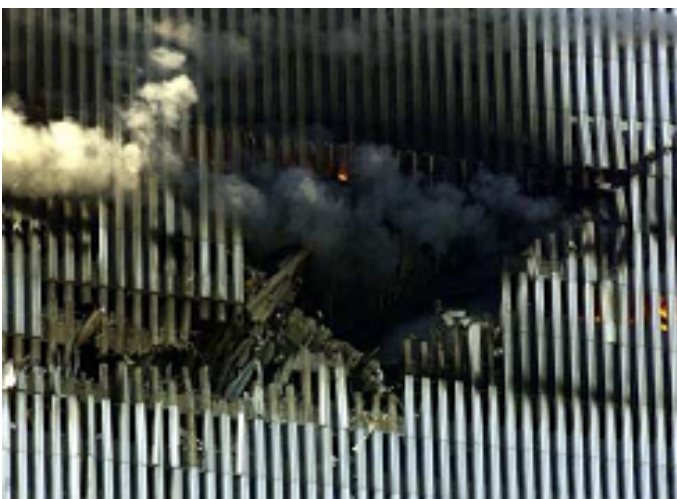
Impact zone of the North Tower (shown from the north side)

But that aside, it is important to quantify how the structural damage played a role in the collapse of the Towers. We previously noted that the collapse of the Towers started on floors with less damage than other floors. In the case of the North Tower, the collapse started at the 98th floor,<sup>6</sup> which had the least amount of structural damage out of all the damaged floors.<sup>7</sup> Not only that, but the upper section of the North Tower started to collapse on the side of the building opposite to where the plane impacted.

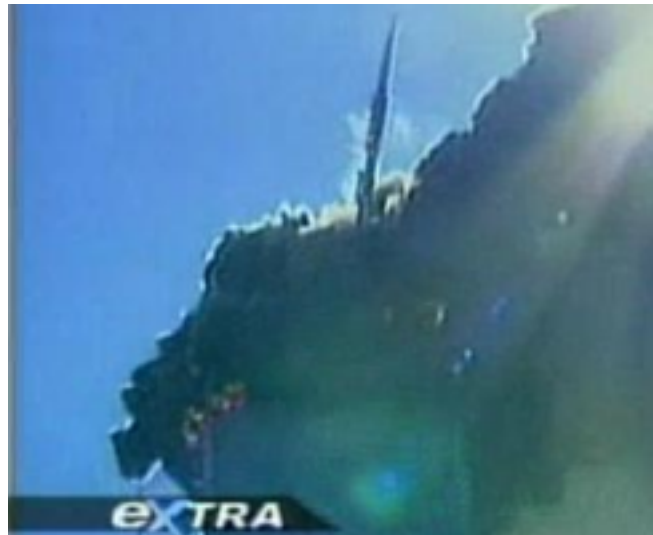
Initiation of collapse of the North Tower (shown from the south side)

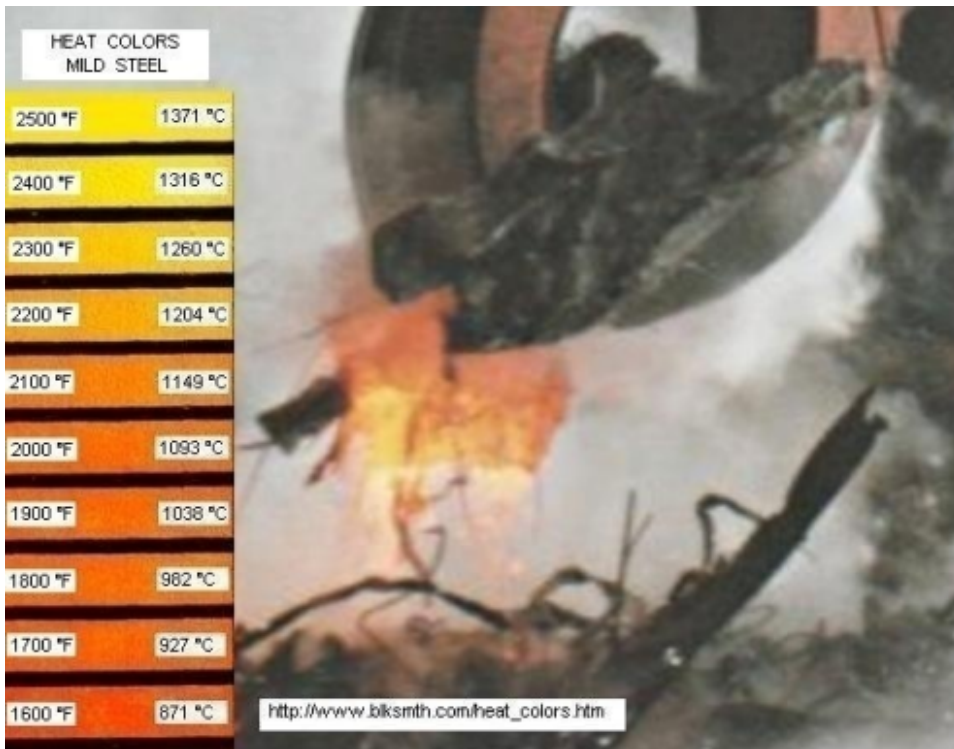
Regardless of whether the obvious molten material shown above is molten steel, iron, or even glass, its color indicates temperatures exceeding 2,300°F. The jet fuel and office fires in the Twin Towers never reached such temperatures.

First off, it is not clear from this statement which photograph Pense is referring to, though it's likely the popular "crane shot."

Second, we have already seen that there were metals that were either melted or evaporated at temperatures well above the melting point of steel and iron. Third, even if the crane photo did show molten glass, it would still need to have been heated to extremely high temperatures, since glass does not begin to give off any visible light until it approaches [temperatures of 2240 °F](#).<sup>15</sup>
